Mynydd Glyn Wind Farm

Draft Environmental Statement

Appendix 10C Site Visit Photo's

Appendix 10C

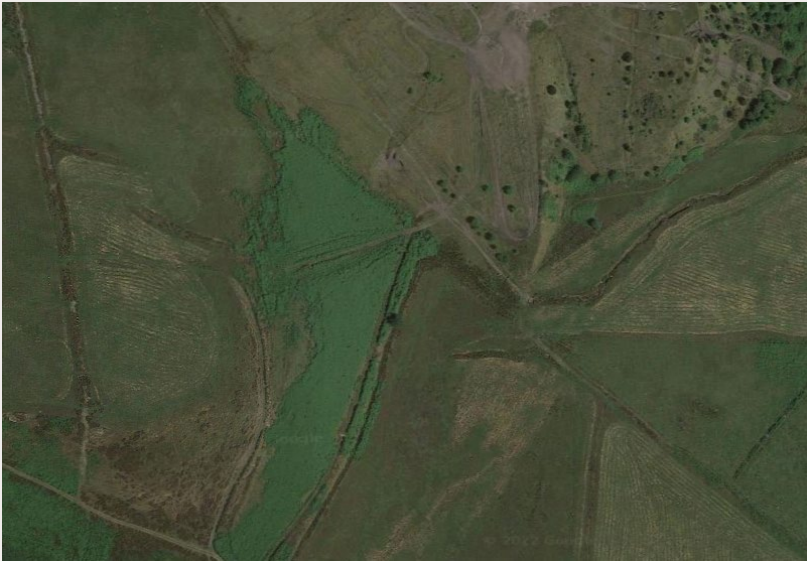
ST 03857 89541	<p>Area identified as being at risk of surface water flooding between T04 and T05</p> <p>This area was inaccessible, but aerial footage (picture 1) shows no evidence of a channel. Surface water flooding on Figure 10.5 is located at the access point between the two fields.</p>

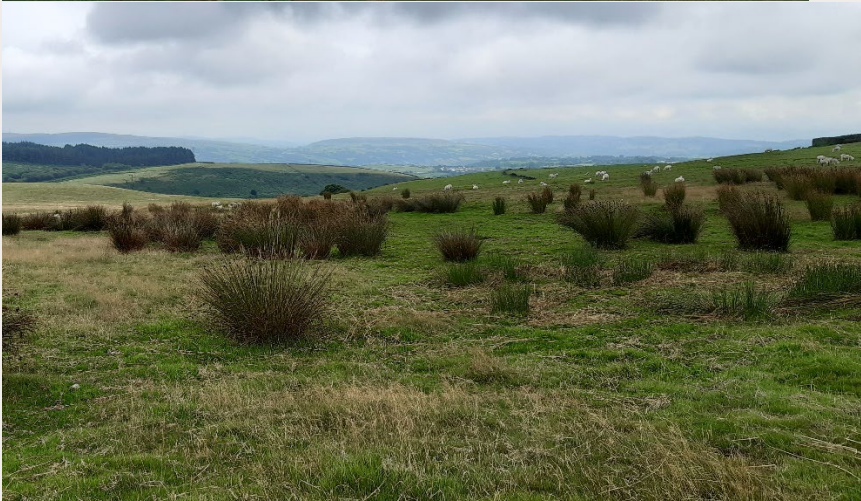
ST 03855 89283	<p>Following the path of mapped surface water flood risk to the south-west, no evidence of a flow or a channel was observed (see picture 2), although there was an observed change in vegetation in this area.</p>
