Mynydd y Glyn Wind Farm

Draft Environmental Statement

Appendix 11A: Phase 1 Geoenvironmental Desk Study

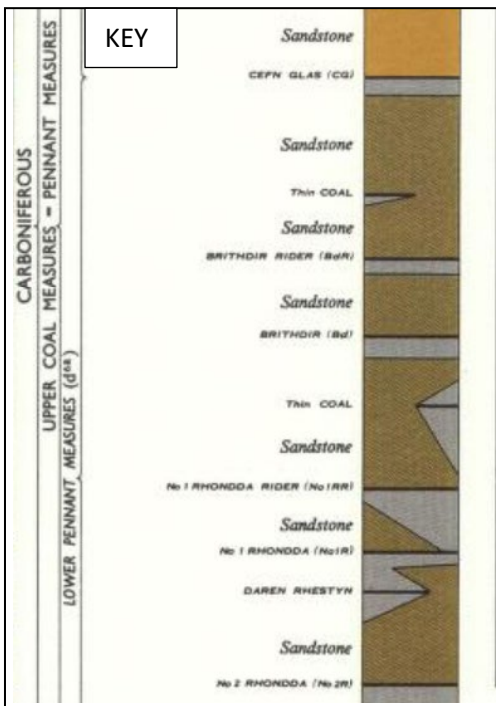
The ground conditions have been derived from a combination of published information, BGS 1:50,000 scale mapping on Geolindex, and the Envirocheck report together with information from the site walkover. An extract from BGS sheet 1:63 360 Pontypridd Sheet 248 is included below and summarised in the following text.

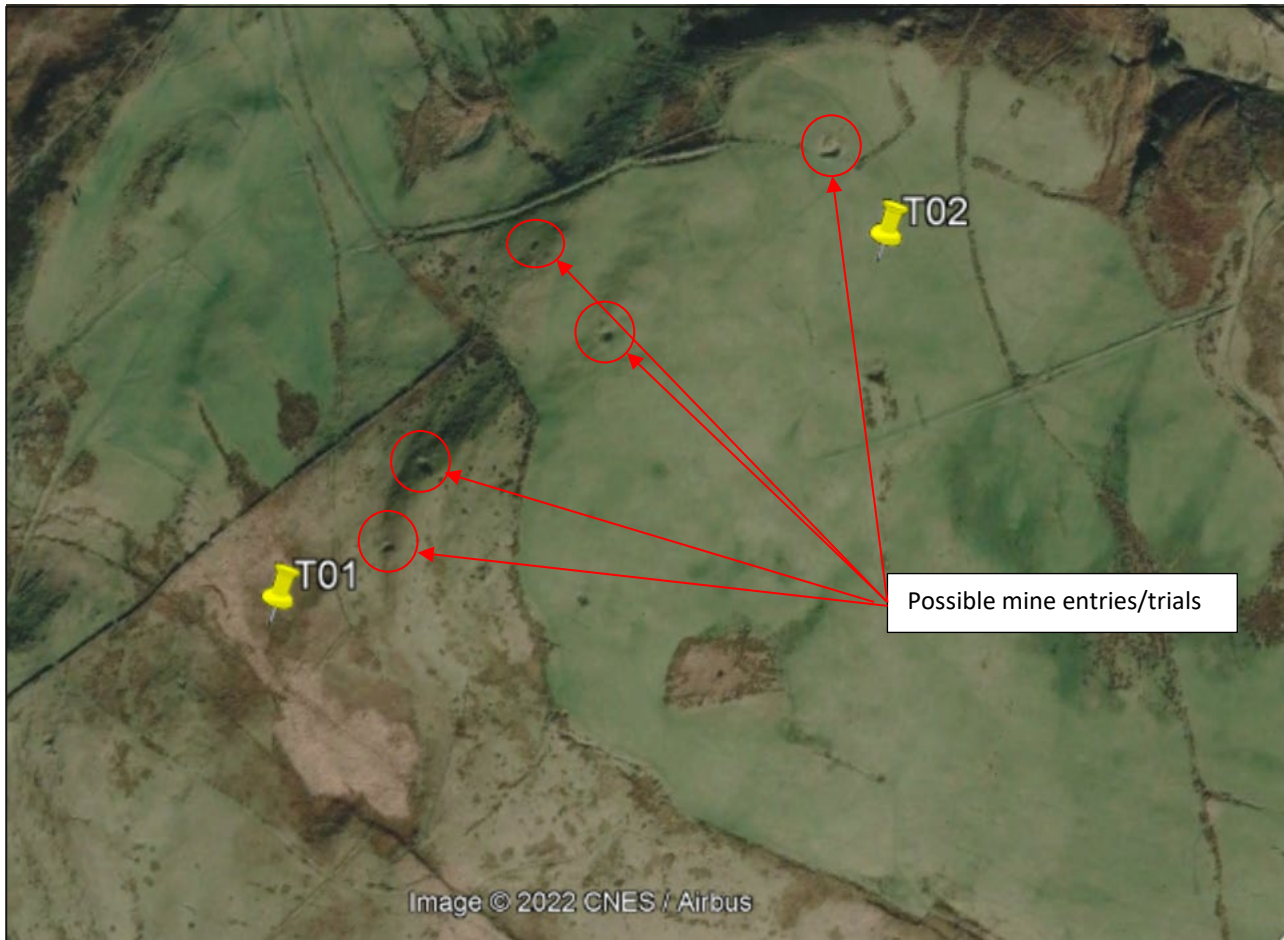
Figure 3: Google Earth Imagery 2021 Showing Location of Possible Mine Trials

As noted above, possible trials or mine entries are identified from Google Earth historical imagery. These are broadly consistent with or above the outcrop of the Brithdir seam as shown in **Figure 3** below, which is an extract from Google Earth 2021 imagery; this date of imagery has been selected as it shows the features most clearly.

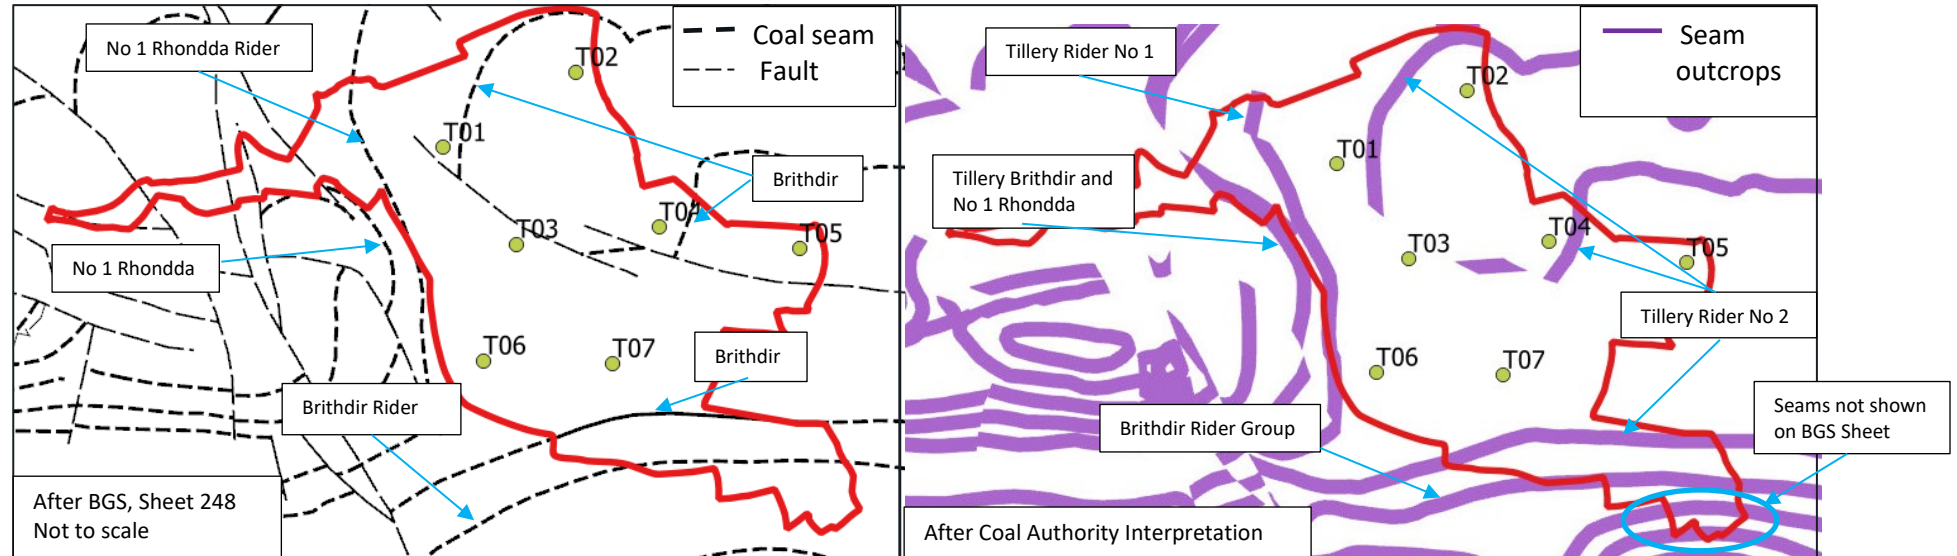
Figure 6: Seam Outcrop Comparison

The CCMRs for the different areas identify a number of coal seam outcrops within and adjacent to the Site. Whilst the overall seam pattern is similar between the BGS and the Coal Authority, there are significant variations in the seam nomenclature, which has potential stratigraphical implications and makes interpretation complex,. The seam outcrops from the two sources are summarised in **Table 4.1** and presented in **Figure 6** as screenshots from the sources.

The BGS layout has been amended with the seam names in accordance with the 1:63,360 mapping. Labelling of the Coal Authority layout is more complex as the figures which accompany the reports do not identify the seams, however, they have been interpreted from the details presented in the 'Outcrops' table in each CCMR obtained.

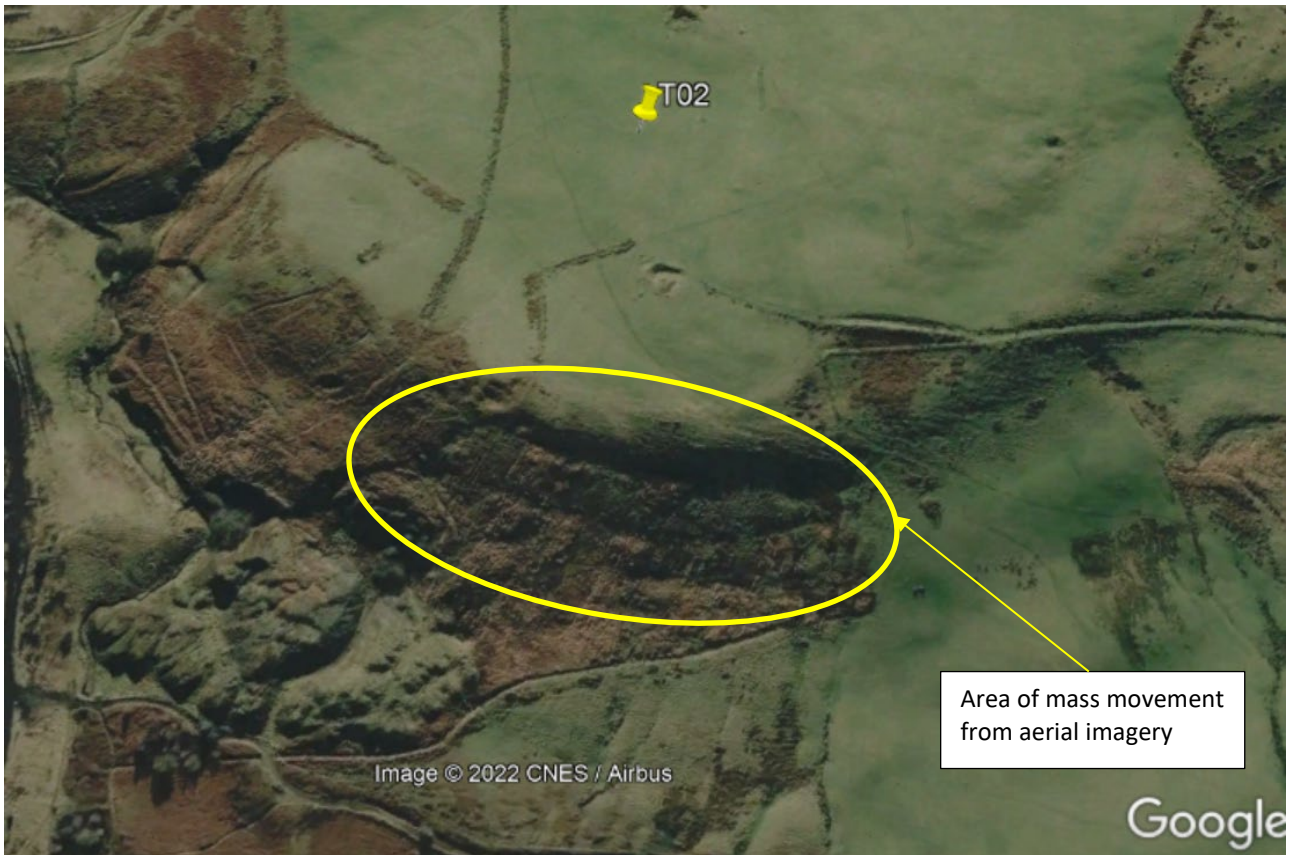
Figure 9: NE Oblique View showing Mass Movement

The published geological information indicates a small area of mass movement on the valley side below and approximately 170 m to the north of T2; this appears to be associated with an area of historical quarrying. The feature is apparent on an oblique image from Google Earth as shown on **Figure 9**, where the scarp/terrace feature is much more clearly defined and steeper than the rest of the northern and north western slope.

The location of this feature on Google Earth overlaps with that plotted on BGS mapping but it slightly different as shown on **Figure 9**.

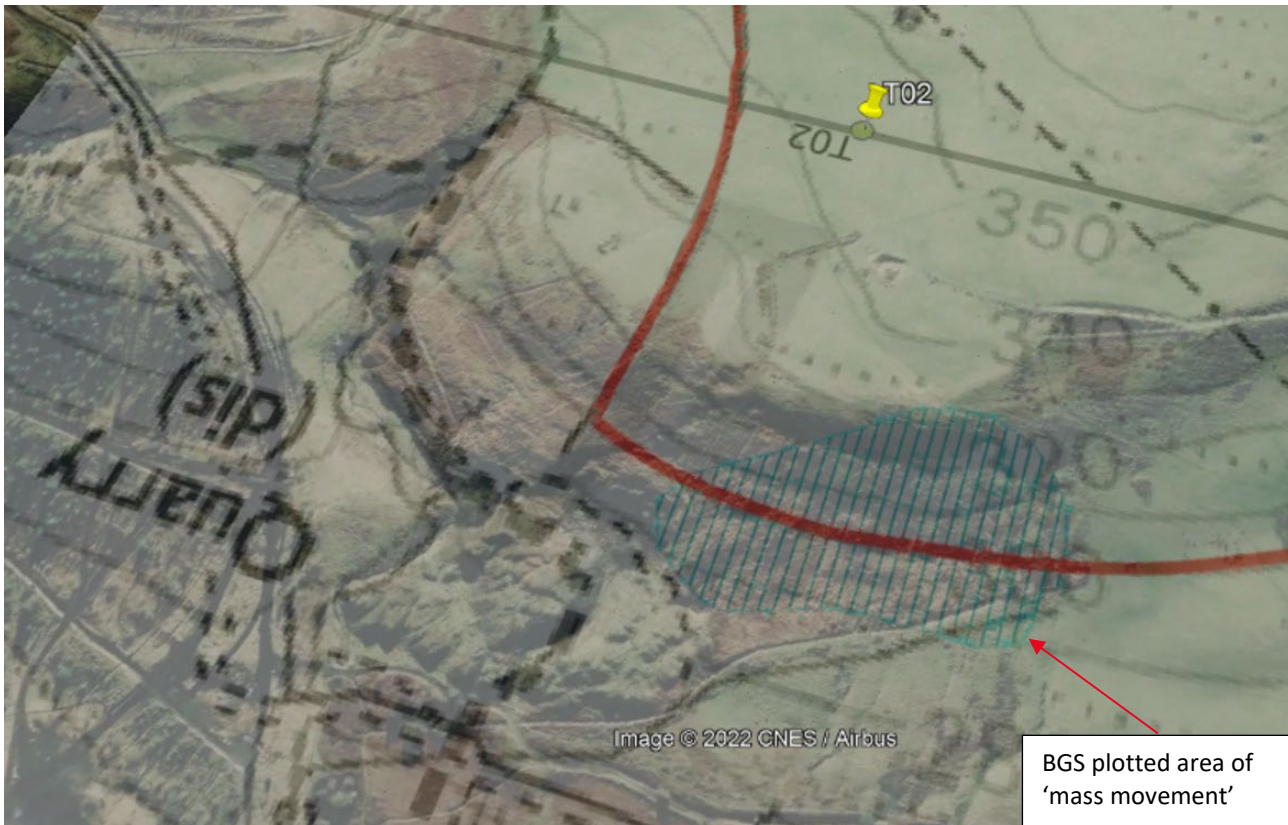
Figure 10: NE Oblique View Showing Mass Movement including BGS Mapped Areas

The geological memoir indicates that landslips are common in the valleys, and particularly affect the lowest major sandstone above the level of the valley fill. The Geological Memoir for an adjacent area (Sheet 232) notes that most of the movement took place during de-glaciation, when the support of valley glaciers was removed. In the Rhondda Fawr valley, the memoir indicates that most of the slips are associated with the No 1 and No 2 Rhondda sandstone units and are mostly defined as rick tumbles, with some rotational element near the back scar. Examination of aerial imagery on Google Earth between 2001 and 2021 has not identified any apparent change in the morphology of the slope in this area. Given that the turbines are on the upper valley slope and the mapped instability is located in an area of historical quarrying, the risk within the proposed design life (30 years) of the Proposed Development is considered to be low; in addition, the imagery above indicates that the movement appears to be linked to the terraced nature of the northern valley slope.

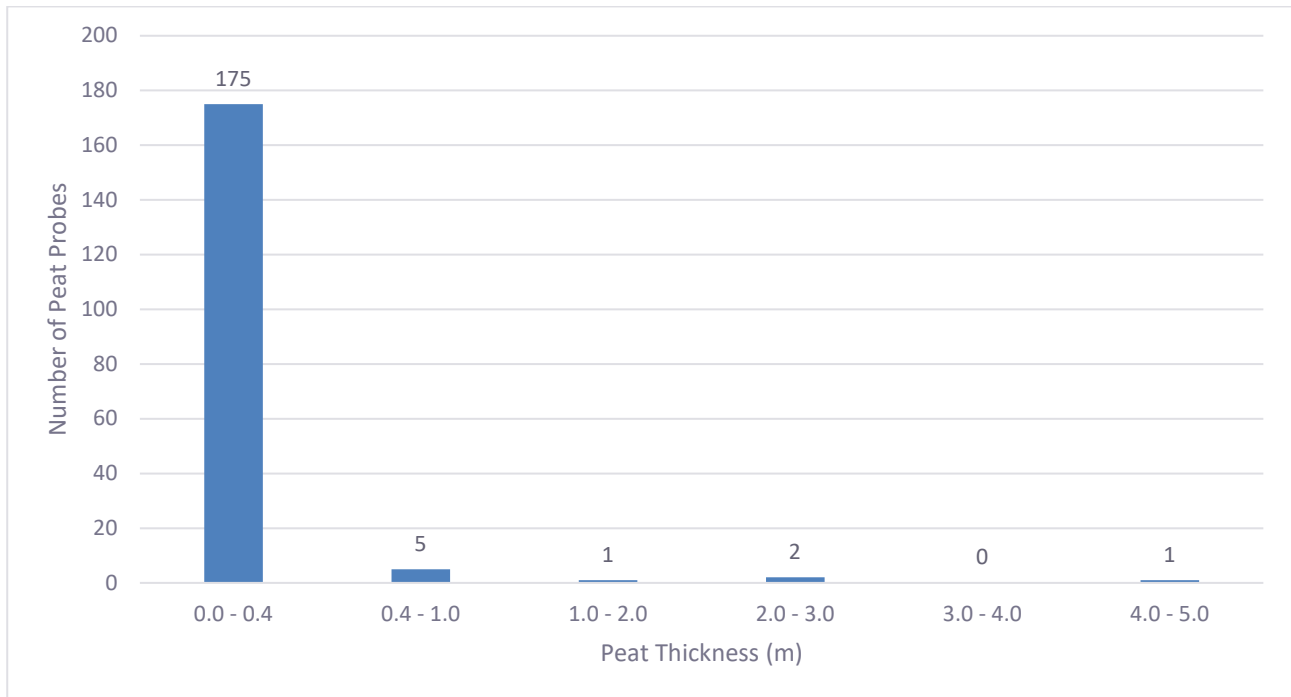
Figure 3.1 – Summary of Peat Survey Data

The Phase 1 peat depth survey was undertaken by Wood on the 14th September 2021 during a period of relatively dry weather. The survey comprised a total of 183 probes taken across the Developable Area, revealing potential peat depths in the range of between 0.00m and >4.10m. The calculated mean depth of recorded peat was 0.13m. The Welsh Government define true peat as being $\geq 0.4\text{m}$ in depth. Figure 3.1 illustrates the spread of survey results.
